WATER DAMAGE/MOLD INVESTIGATION

**South High School
490 Long Pond Road
Plymouth, Massachusetts**

Prepared by:
Massachusetts Department of Public Health
Bureau of Environmental Health
Indoor Air Quality Program
November 2018

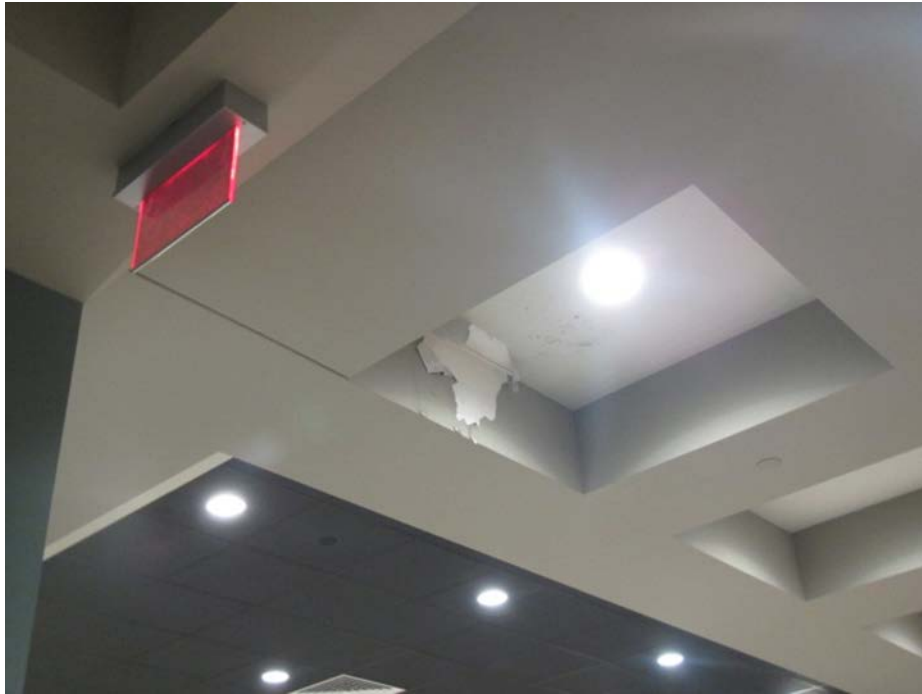
Picture 1

- **Auditorium:** A previous leak was reportedly fixed in this area by the roofing manufacturer, Sarnafil, which is on warranty. Water damage in the form of peeling paint and stained ceiling was observed (Picture 1). School maintenance personnel reported that the work was on a repair list with a private contractor, RebuildEx Damage Restoration. No further damage was reported and no active water penetration/wet conditions were observed/measured via moisture meter on porous materials (i.e., carpet, upholstered seats) beneath the area (Picture 2).

Peeling paint and stained ceiling in auditorium

1. Continue with plans to make repairs to water-damaged building materials in the auditorium.
2. If not already done, remove water-damaged section of drywall in mezzanine outside of weight room. Investigate why condensation is forming in this area and make repairs to prevent further water damage.

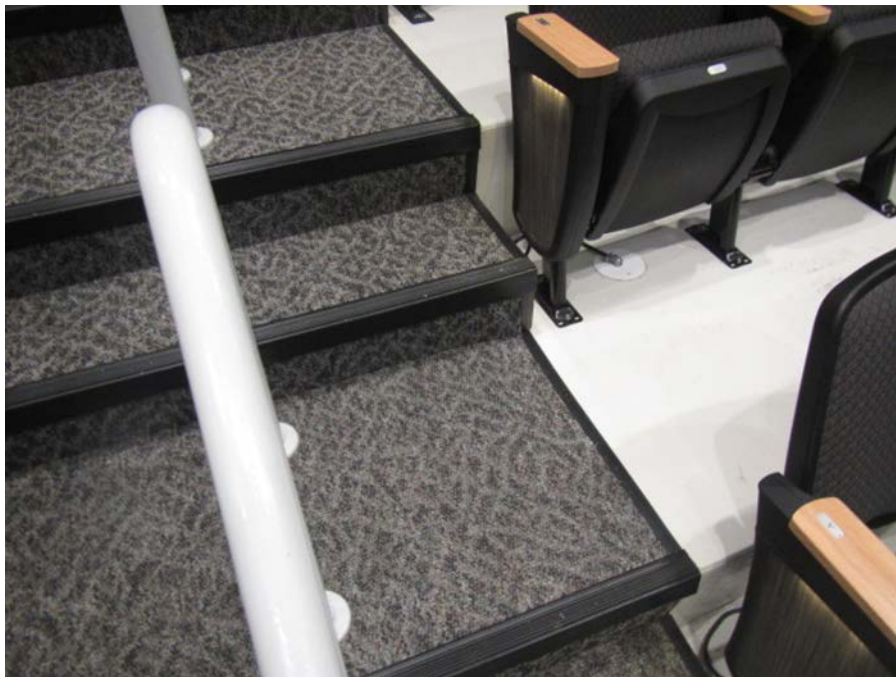
Picture 2

Carpet, seats and floor directly beneath area of previous leak in auditorium, showing no signs of current leaks or water damage

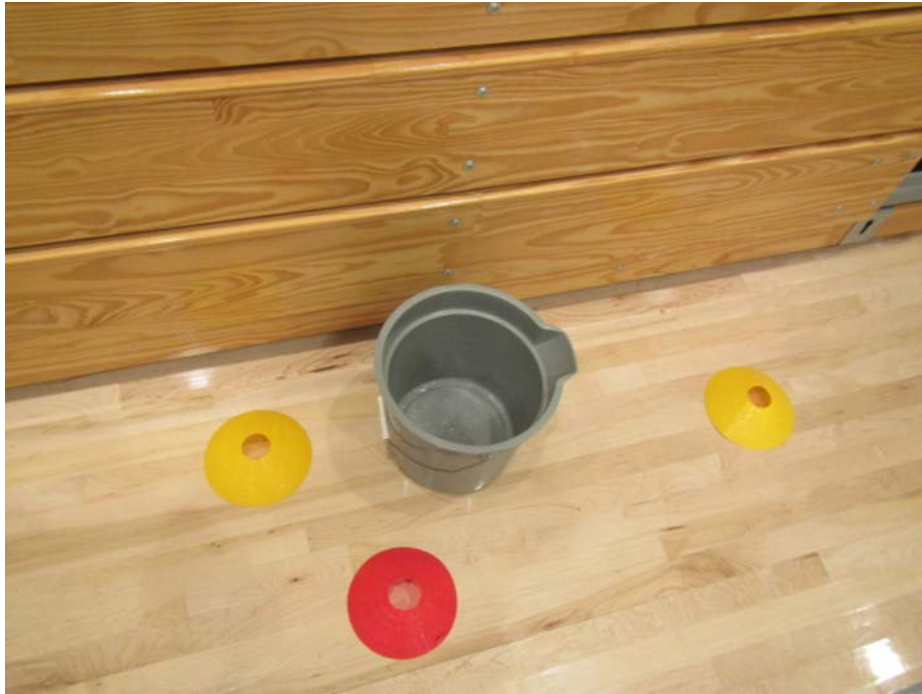
Picture 3

- ***Gymnasium:*** At the time of assessment, water was noted dripping from the ceiling into buckets in two places. Although, rain was heavy at times, the amount collected in the buckets appeared minimal. No porous building materials (e.g., carpet, ceiling tiles, gypsum drywall) are located in areas of leaks. The water impacted materials are wooden floor (semi-porous) and metal building components (Pictures 3 through 6).

Bucket in gym collecting dripping rainwater, note minimal amount

3. Work with roofing contractor/manufacture to determine source of leaks in the gym and make repairs as needed.
4. In the interim, monitor for continued leaks and catch in containers (e.g., buckets/mop) to prevent damage to the floor. Post “hazard/wet floor” signs as needed, to prevent injury to occupants/staff.

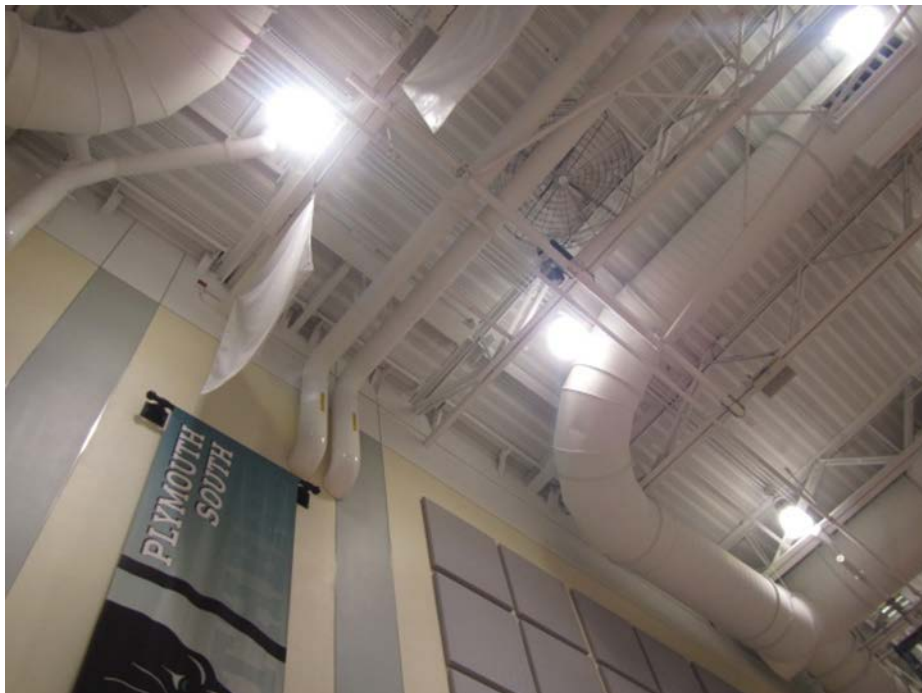
Picture 4

Ceiling/area above bucket in preceding picture

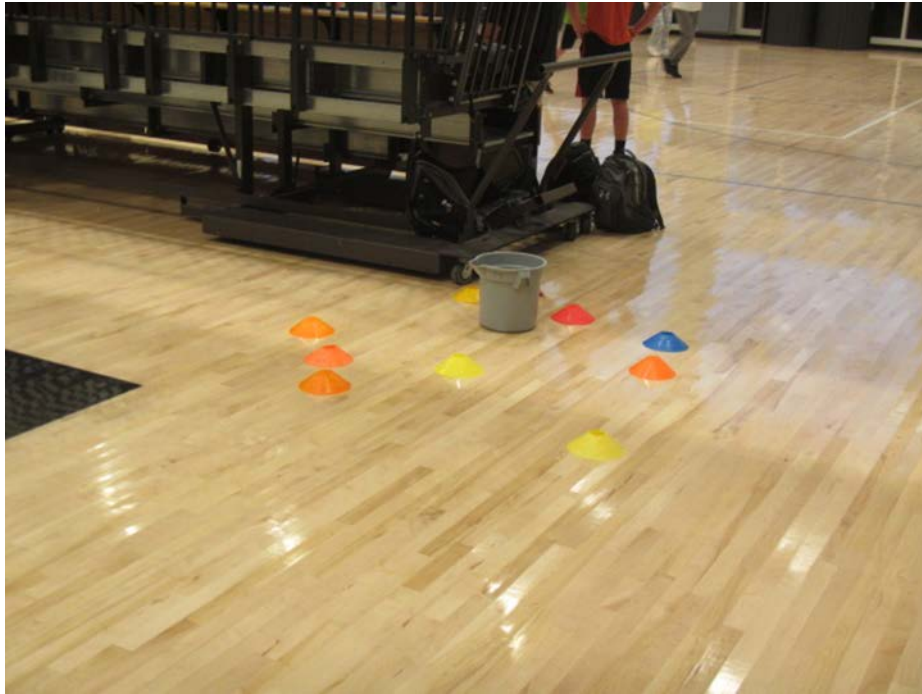
Picture 5

2nd bucket in gym collecting dripping rainwater

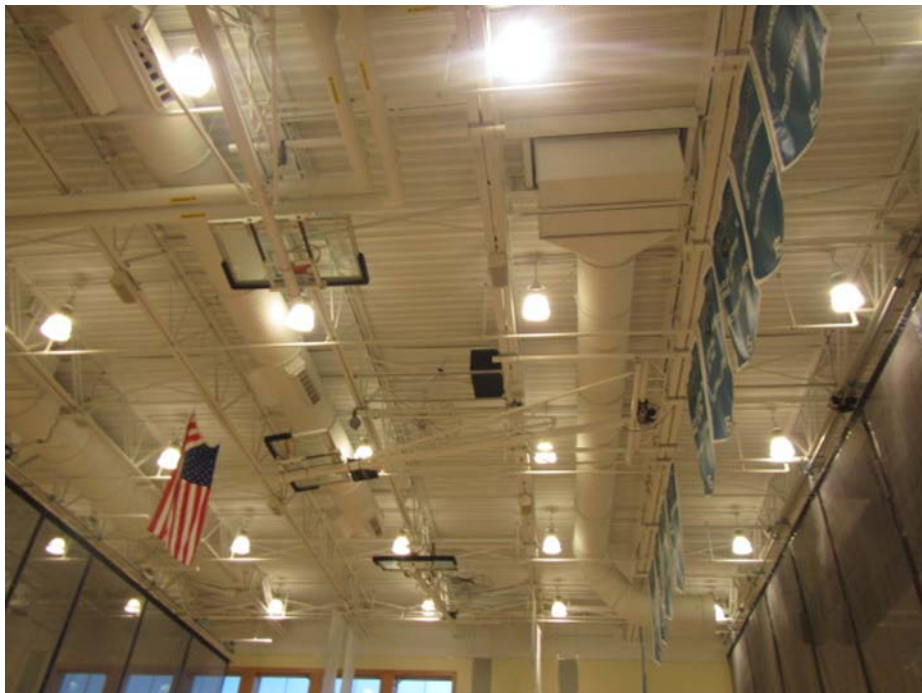
Picture 6

Area above 2nd bucket in preceding picture

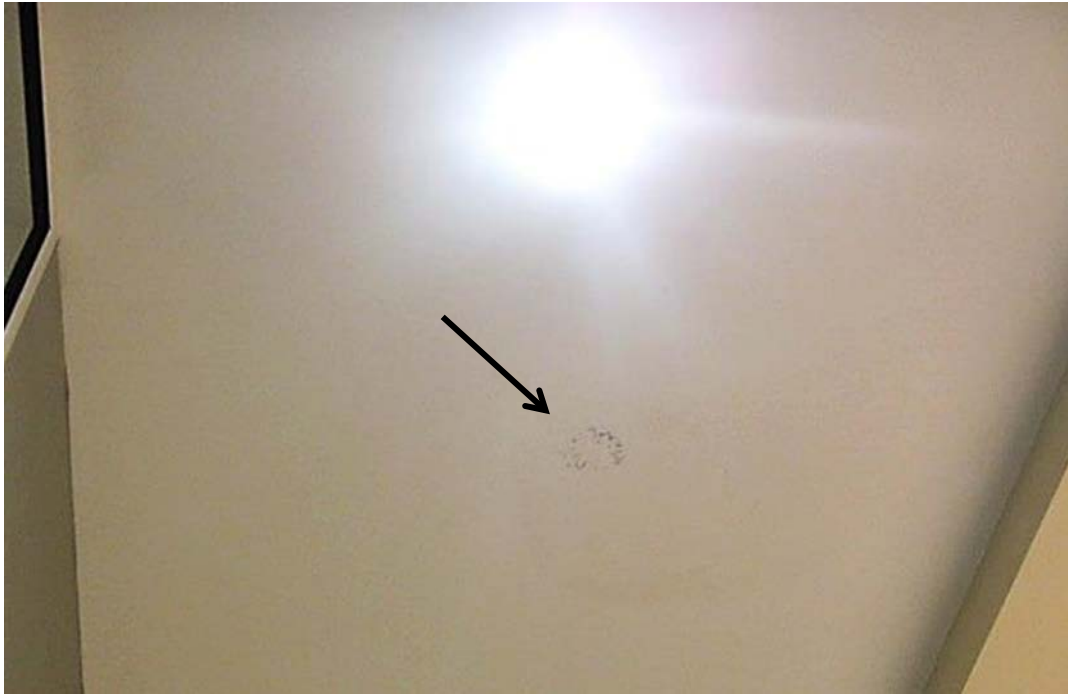
Picture 7

- ***Weight Room:*** Previous water damage had reportedly occurred and was repaired by the roofing manufacture. No evidence of leaks was observed in the weight room at the time of assessment. However, water-damaged/dark staining; which may be mold growth on ceiling material in the mezzanine outside the weight room was observed (Picture 7). School maintenance officials reported that the stain is likely due to condensation on a metal duct that traverses the area above it. BEH/IAQ staff recommended cutting out this section of drywall and investigating source of moisture.

Dark staining/possible mold growth (arrow) on ceiling outside of weight room

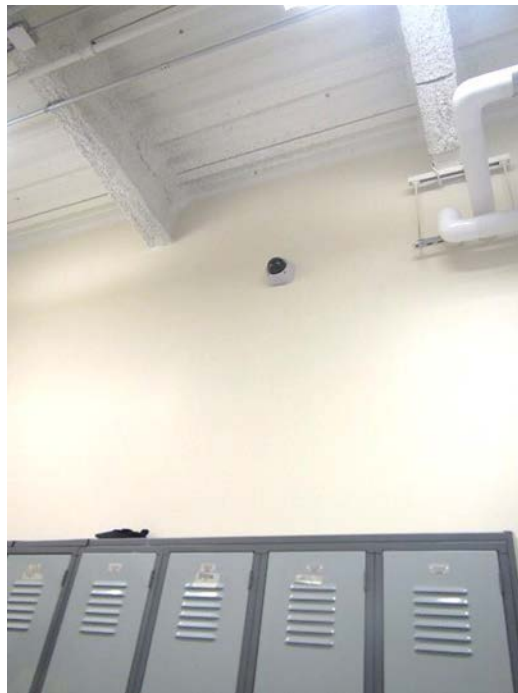
Picture 8

- ***Loading dock area:*** The cafeteria loading dock area was known to have a leak in flashing, which has since been repaired. Although staining/debris from the previous leak remained on top of the lockers below (Picture 8), no current water penetration/further damage was reported or observed.

Cafeteria loading dock area of previous leaks

5. Clean lockers in cafeteria loading dock area and monitor for any further leakage.
6. Encourage staff to use existing reporting systems in place (e.g., School Dude) to report issues such as leaks, repairs and general maintenance needs.

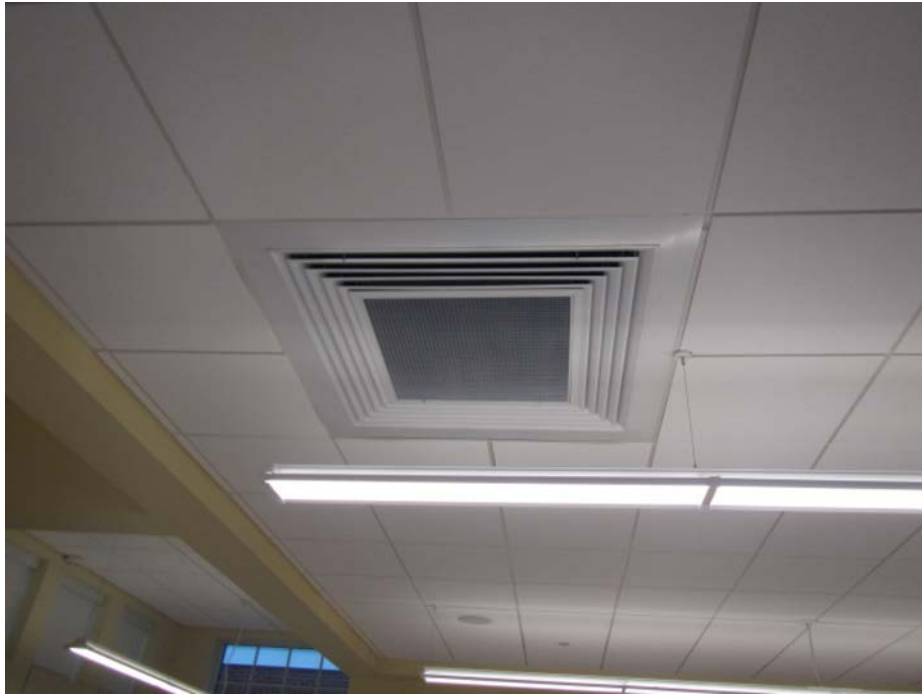
Picture 9

- ***HVAC units:*** The units in use at the SHS are called chilled induction units, which are located above the suspended ceiling (Pictures 9 through 11). The number of units in each room depends on size. It was reported in the complaint, that school staff must physically drain each unit with a hand-held wet/dry vac (Picture 12). This was confirmed by Mr. Arthur Montrond, Facilities Director, who explained that instead of each unit being piped/drained to the exterior, the units collect water in a small cylinder equipped with a float/trigger. Unlike a conventional drip pan that collects a large amount of water that can overflow/spill above ceiling tiles, the cylinder is small in nature and enclosed (Picture 11), which prevents spillage/water damage. The trigger is set to deactivate the unit at less than an inch of water. A computerized monitoring system indicates when the units need service (e.g., draining).

Induction unit in classroom

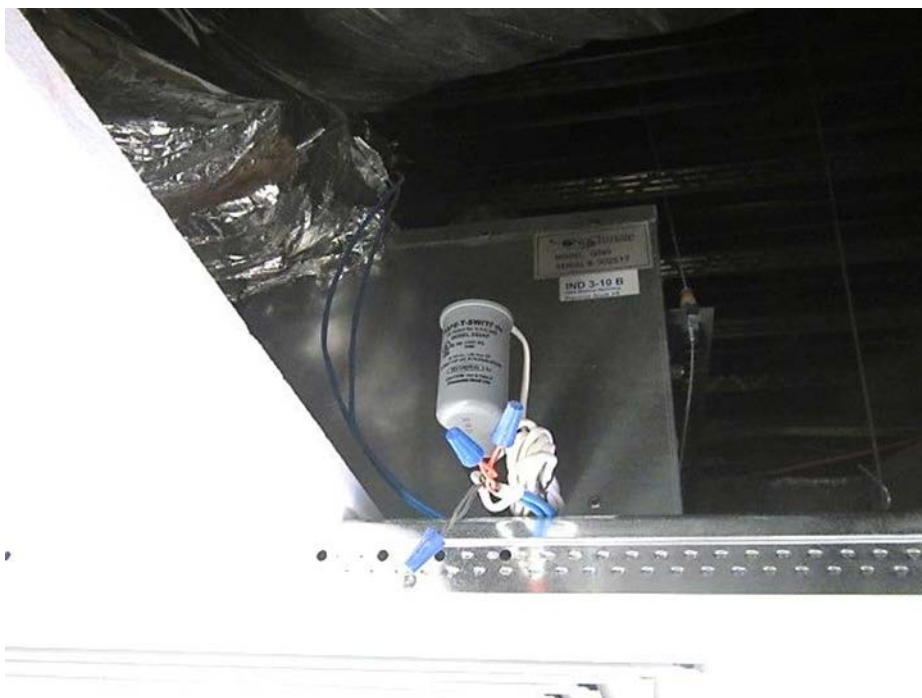
Picture 10

Induction unit above ceiling tile system, note plastic cylinder for water collection

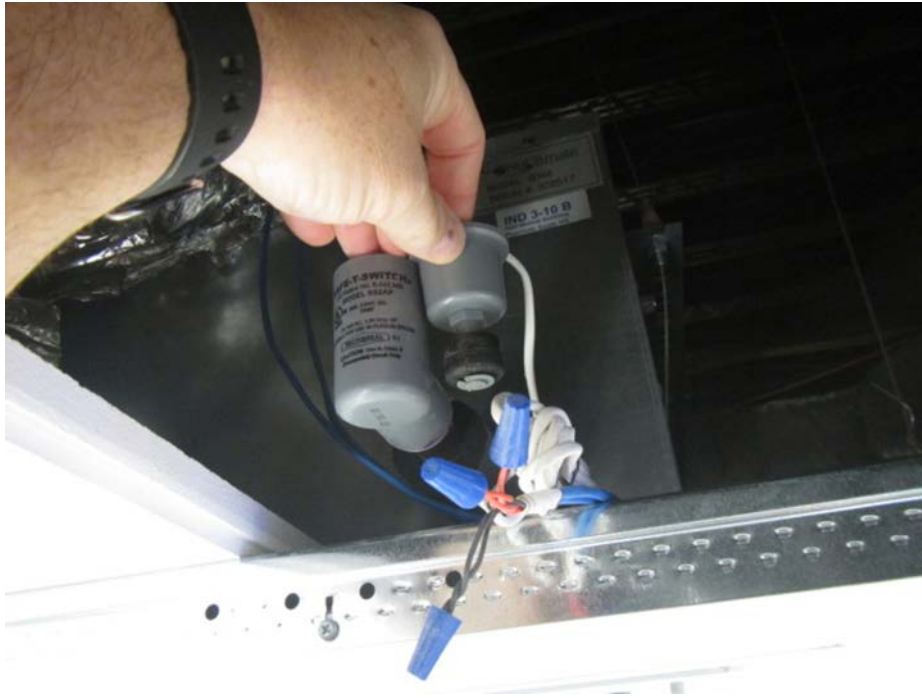
Picture 11

Float/trigger mechanism inside water collection cylinder

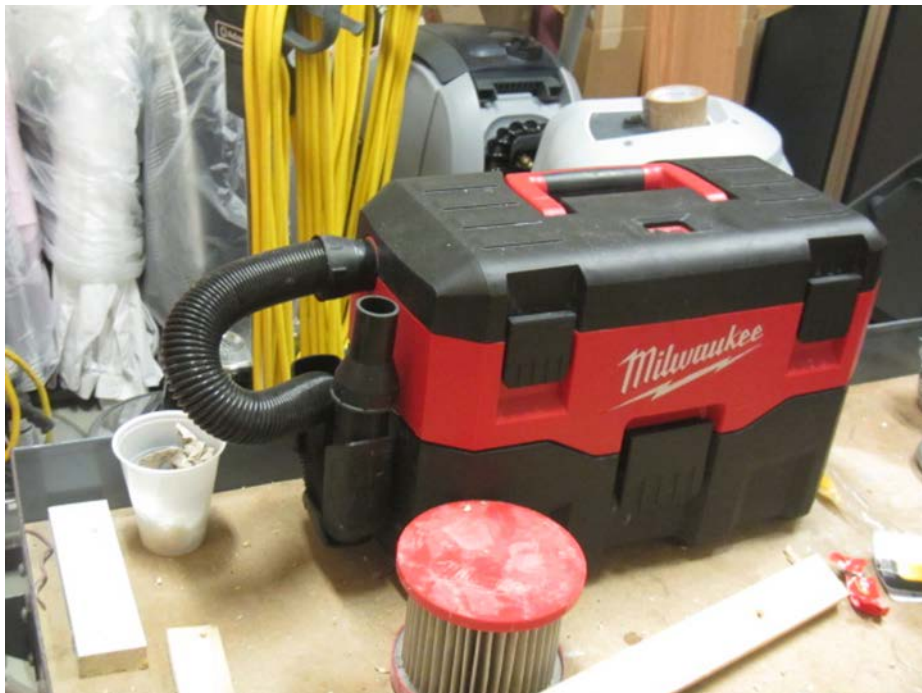
Picture 12

Hand-held wet/dry vac used to drain induction units
